Missouri River Shallow Water Habitat Accounting Report – 2010

Omaha District Missouri River Shallow Water Habitat Report December 2010

OFFICE REPORT
Shallow Water Habitat Reconnaissance
Missouri River Chutes, Omaha District
AUGUST 2009

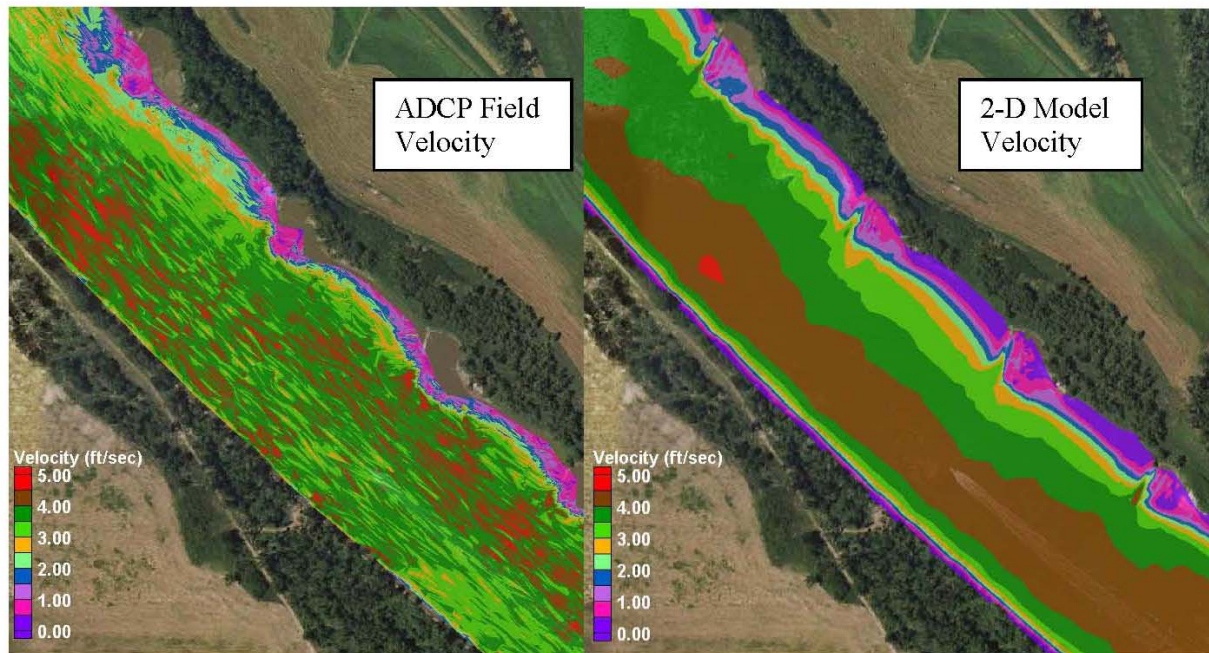
Figure 1. ADCP and Computed Bend Velocity Distribution.

bend velocity distribution. A comparison of the field measured and model computed bend velocity is shown in Figure 1.

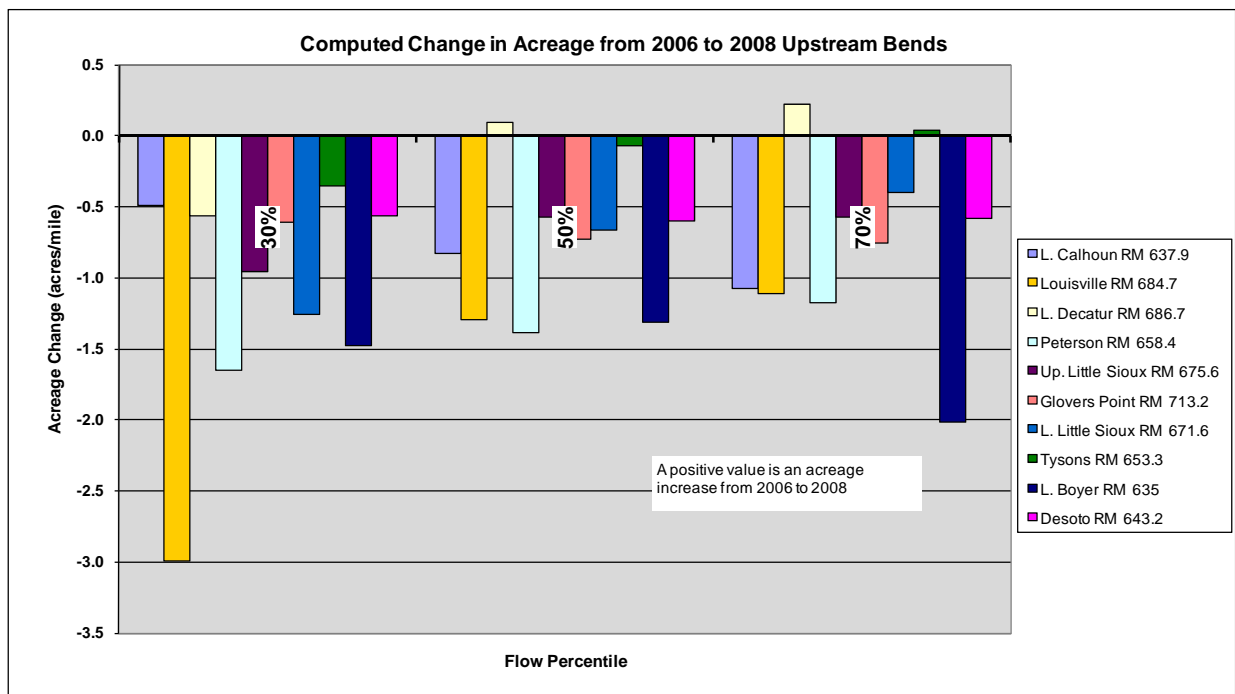
Figure 2. HAMP Data SWH Comparison for 2006-2008.

The HAMP data analysis results indicate a slight decline in SWH from 2006 to 2008. The small magnitude decline may not be significant. However, the data does demonstrate that fluctuation will occur in SWH. The annual variation may be a result of computation methods, data collection methods, the abnormally low flows experienced during the survey period, an actual trend, or a combination of all the above. The analysis of HAMP bend data is complex and can be viewed in a number of different ways. Refer to the annual HAMP evaluation reports (USACE, 2009) for further details. Results of SWH comparisons using HAMP data are summarized in Figure 2.

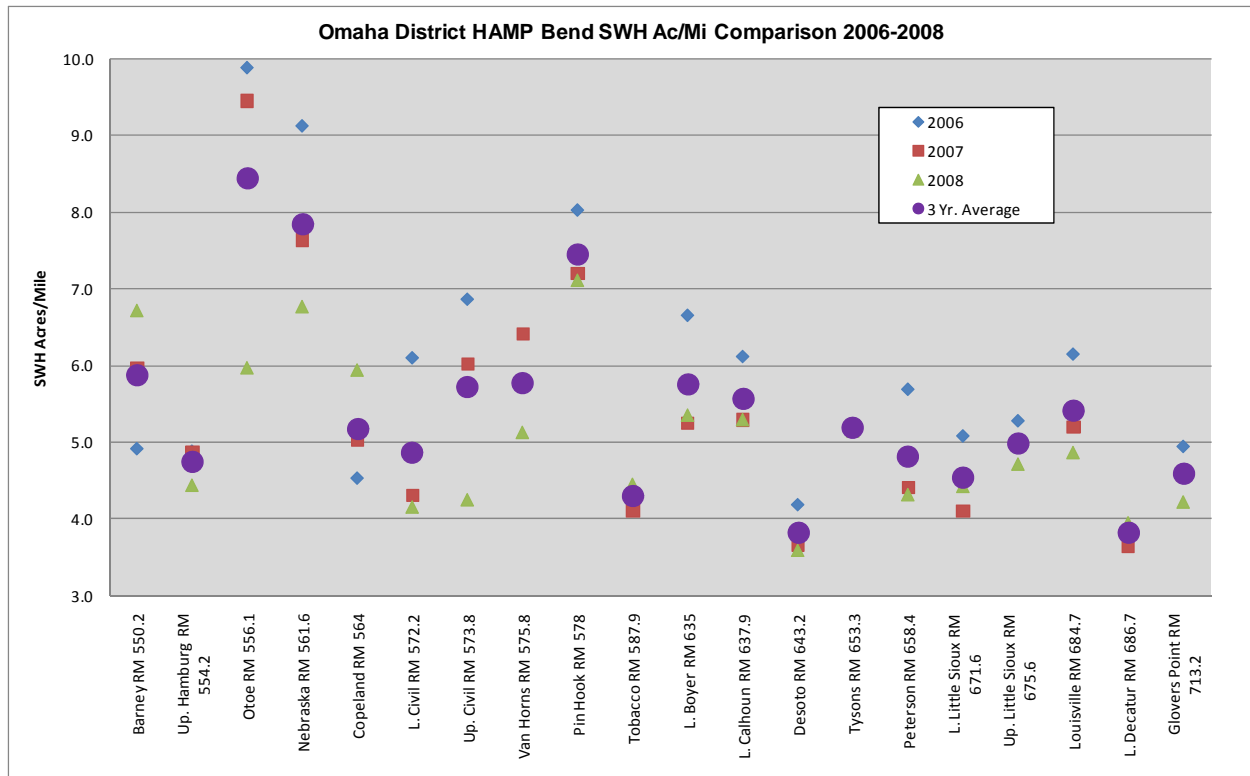
Figure 3. HAMP Data SWH Comparison and Bend Average, 2006-2008.

HAMP data was also evaluated to determine the August 50% exceedance flow average SWH for each bend. Results from this analysis are illustrated in Figure 3.

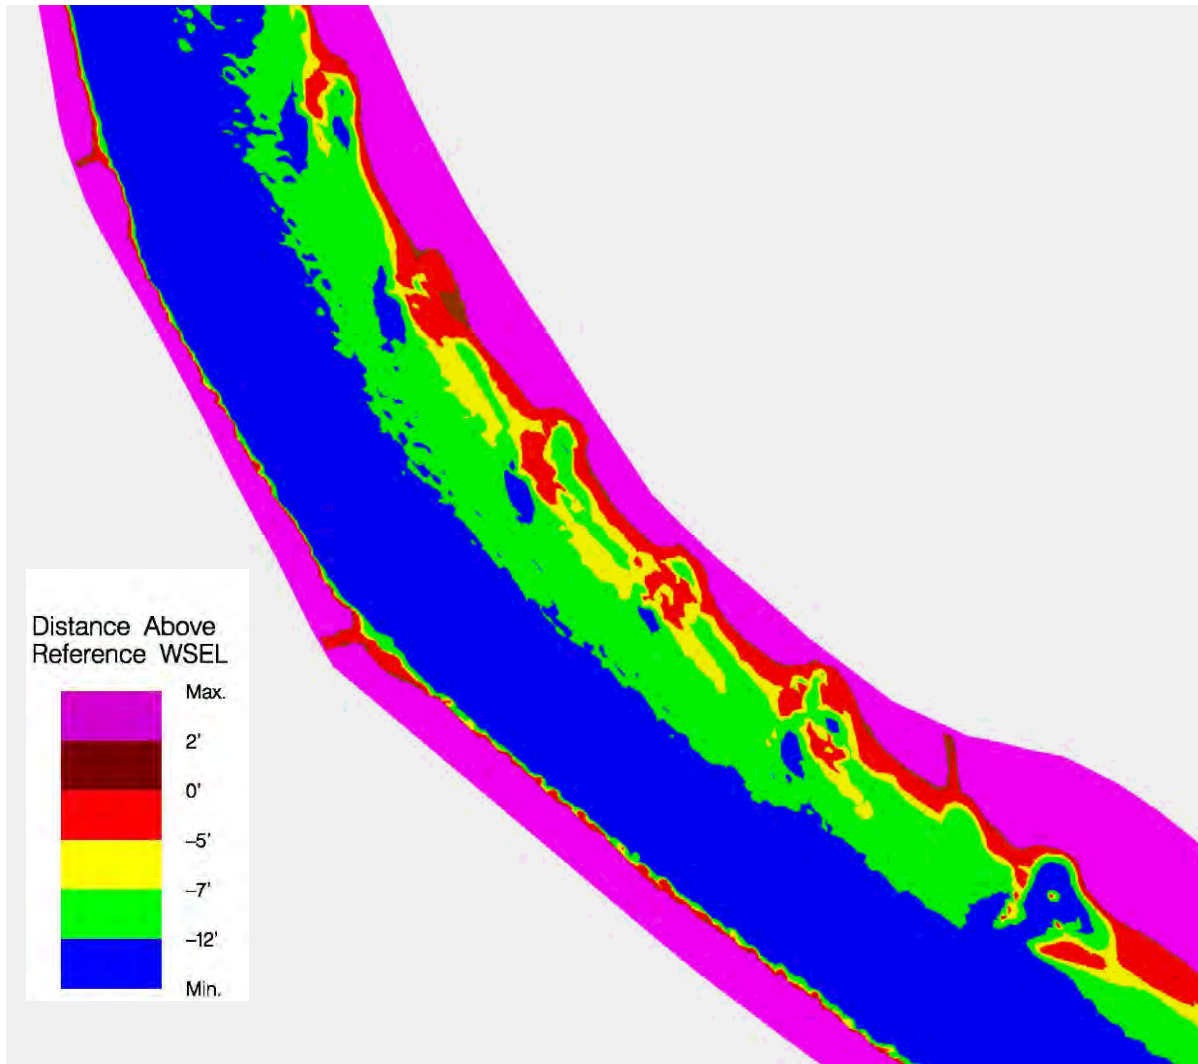
Figure 4. Example Bend Depth Shaded Plot, Nebraska Bend, August 50% Duration Flow

Survey data was evaluated with CADD software using the LiDAR data set from March 2008. Unfortunately, the LiDAR data set from November 2006 would have required a significant conversion effort to be suitable for use which was beyond the intent of this evaluation. The LiDAR dataset was evaluated for coverage extent. This data provides accurate information regarding the structure elevation, bank toe, and top of bank elevation. Analysis was performed in accordance with standard operating procedure (SOP) ENG-2001 (USACE, 2006). A river sloping water surface was constructed for the August 50% flow. CADD was employed to compute the difference surface between the sloping water surface and the LiDAR topographic elevations. The difference surface may be shaded to illustrate depth ranges and determine SWH acreage. An example plot of the depth shaded map at Nebraska Bend is shown in Figure 4. Within Figure 4, the red shaded areas correspond to SWH for the August 50% exceedance flow.

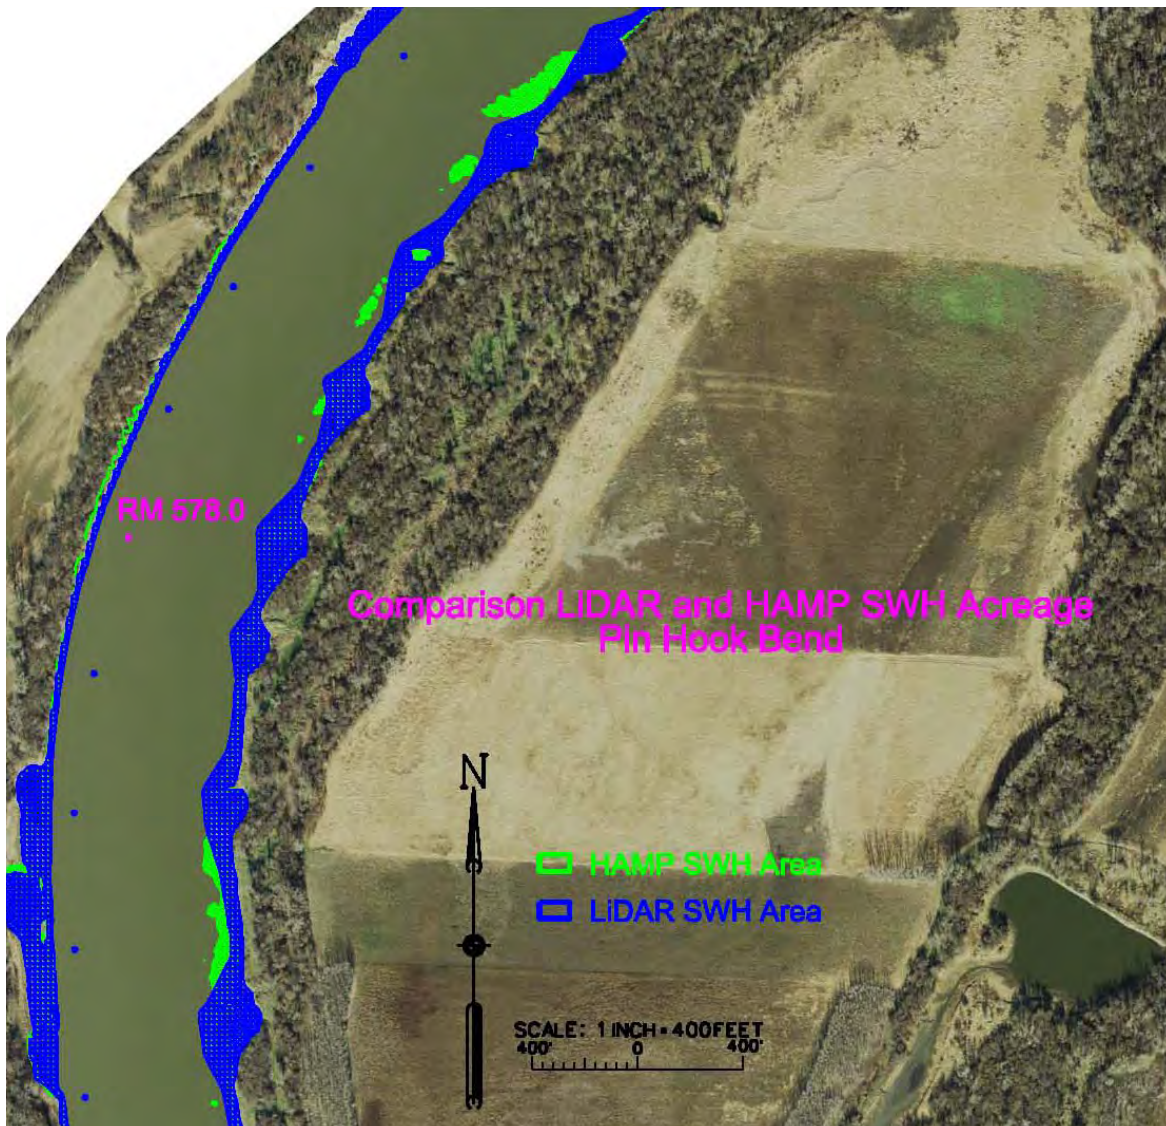
Figure 5. Comparison LiDAR and HAMP SWH Acreage, Pin Hook Bend.

When comparing the LiDAR and HAMP acreage values, it is apparent that each method has potential accuracy concerns. The HAMP data set, which was unable to survey in the near bank region, appears to underestimate actual acreage. The LiDAR dataset, which does not include data within the pools, appears to overestimate acreage in the near bank region due to bed topography variation. A plan view comparison illustrating the difference between the two methods is illustrated in Figure 5.

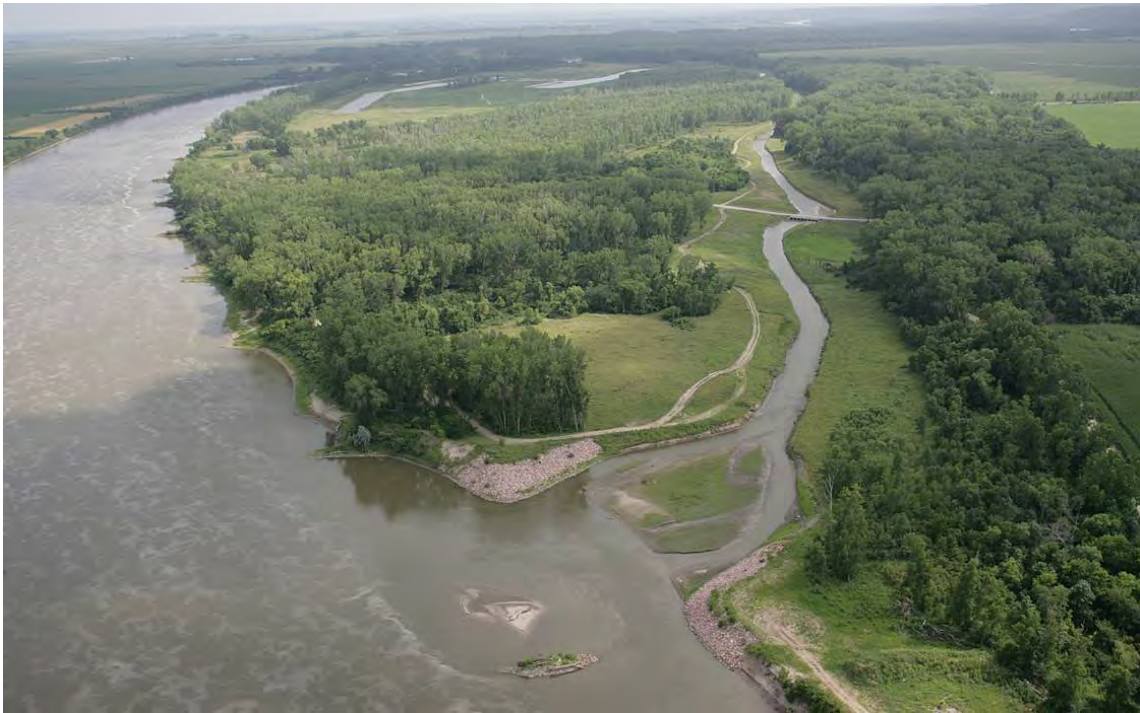
The riprap lining the inlet of the channel looked to be in fine, stable condition. The sills in the river at this bend were between 3-4' out of the water.

Figure 1 - Photo August 2008 Glovers Point inlet.

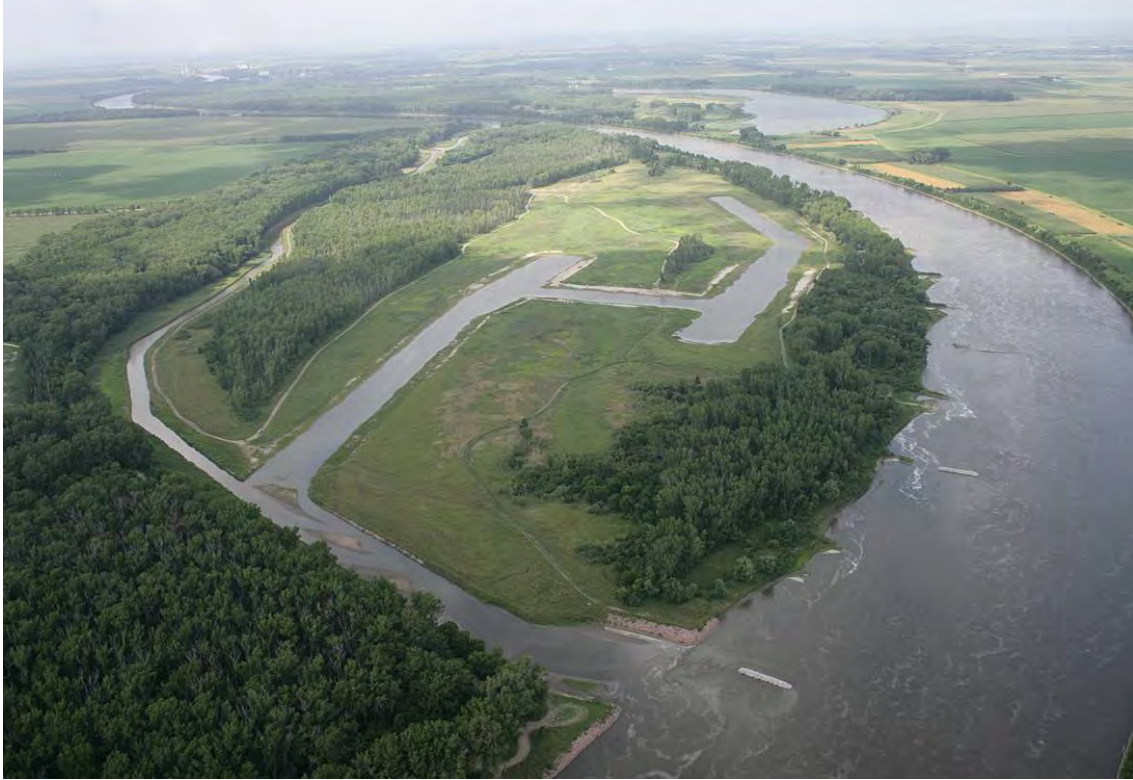
Deposition is occurring in the downstream area of the chute and entrance to the backwater area. Deposition bars can be seen in Figure 2 and deposition was verified in the 2008 surveys from near the backwater entrance to the outlet. The design for the backwater area had 2 holes about 12 to 15 deep, one in each arm.

Figure 2 – Photo August 2008 Glovers Point outlet. Note chute and backwater

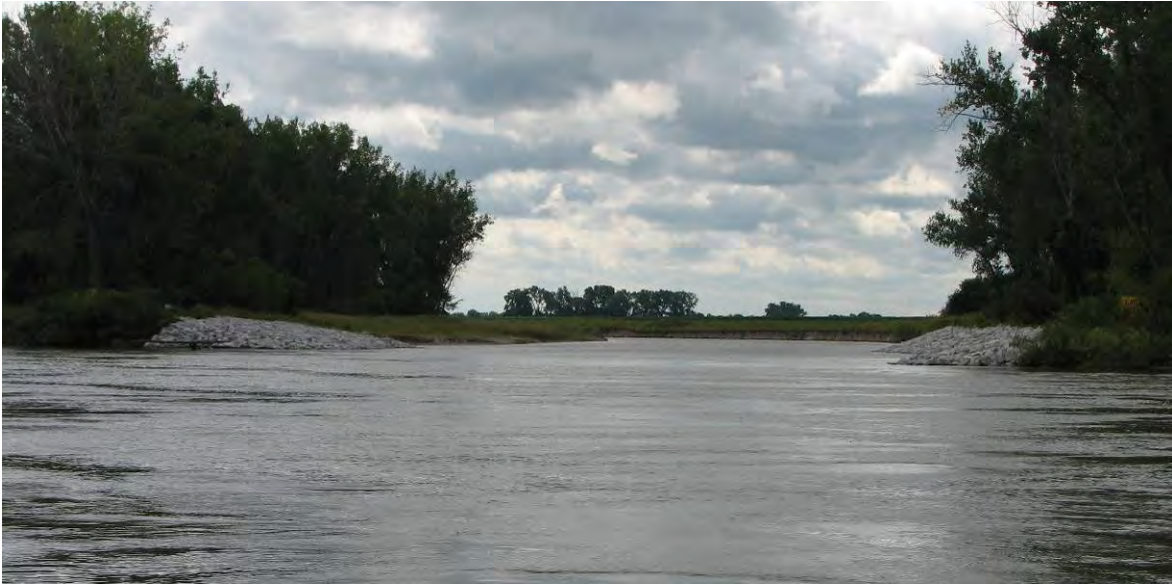
Figure 5 – Photo August 2009 Middle Decatur inlet. Bank protection at inlet looks stable.

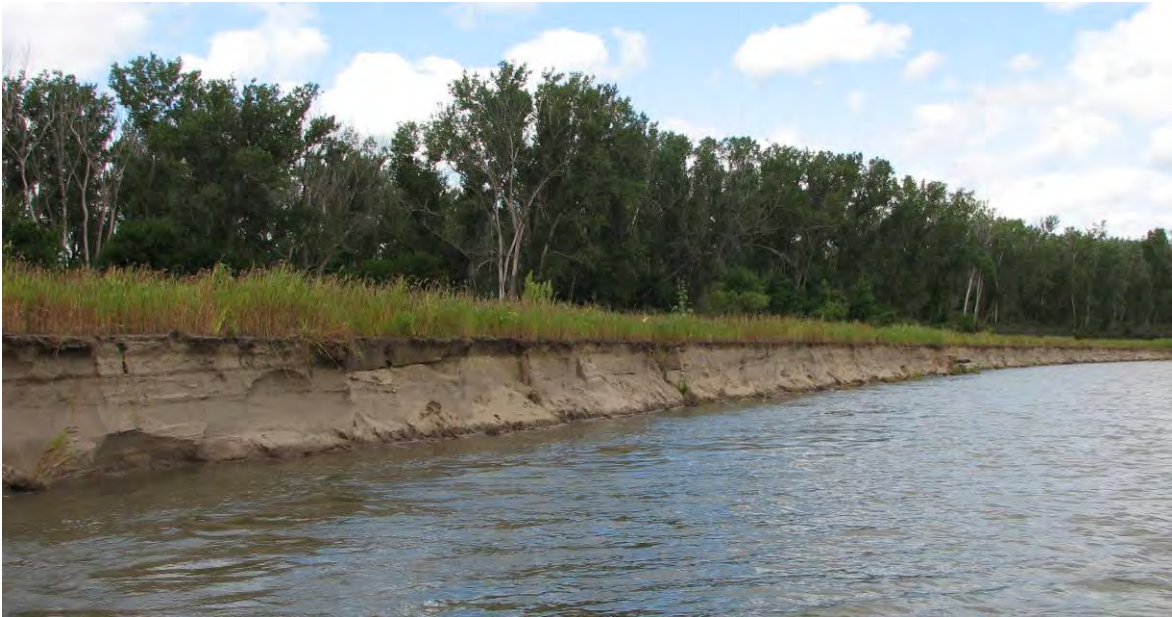
Figure 6 – Photo August 2009 Middle Decatur Chute, in chute looking upstream . Vertical eroding banks on both sides of chute. Bank material consists of sand.

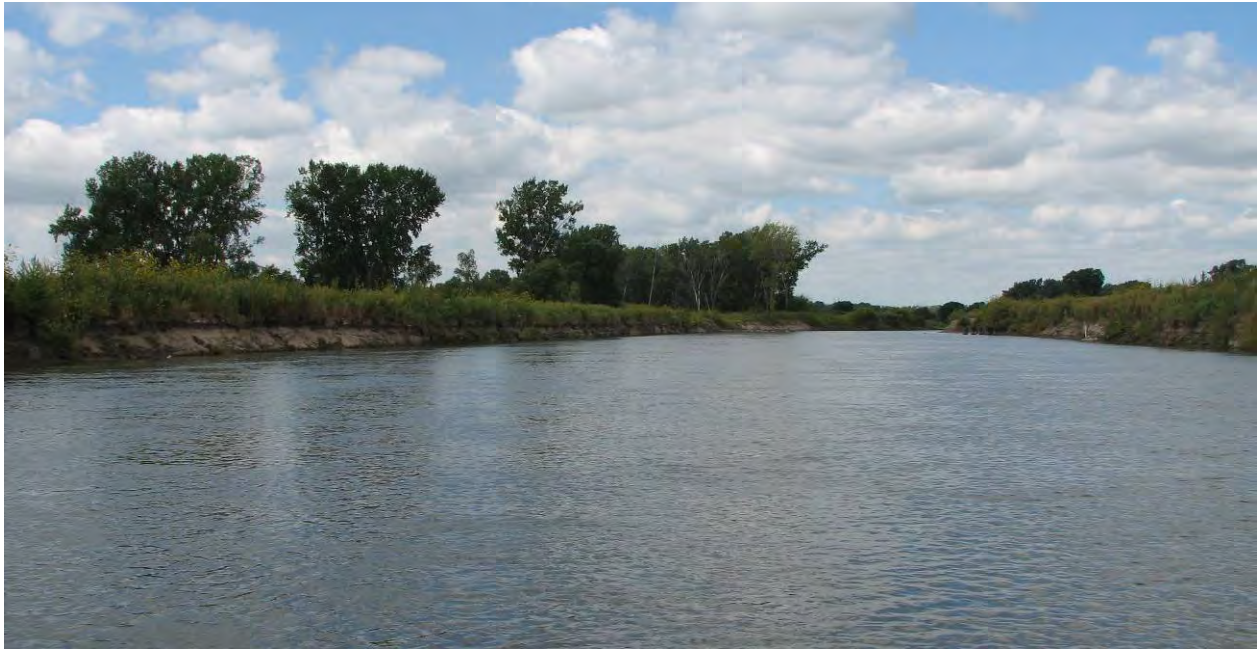
Figure 9 – Photo August 2009 Lower Decatur. Note vegetation, but still some bank erosion.

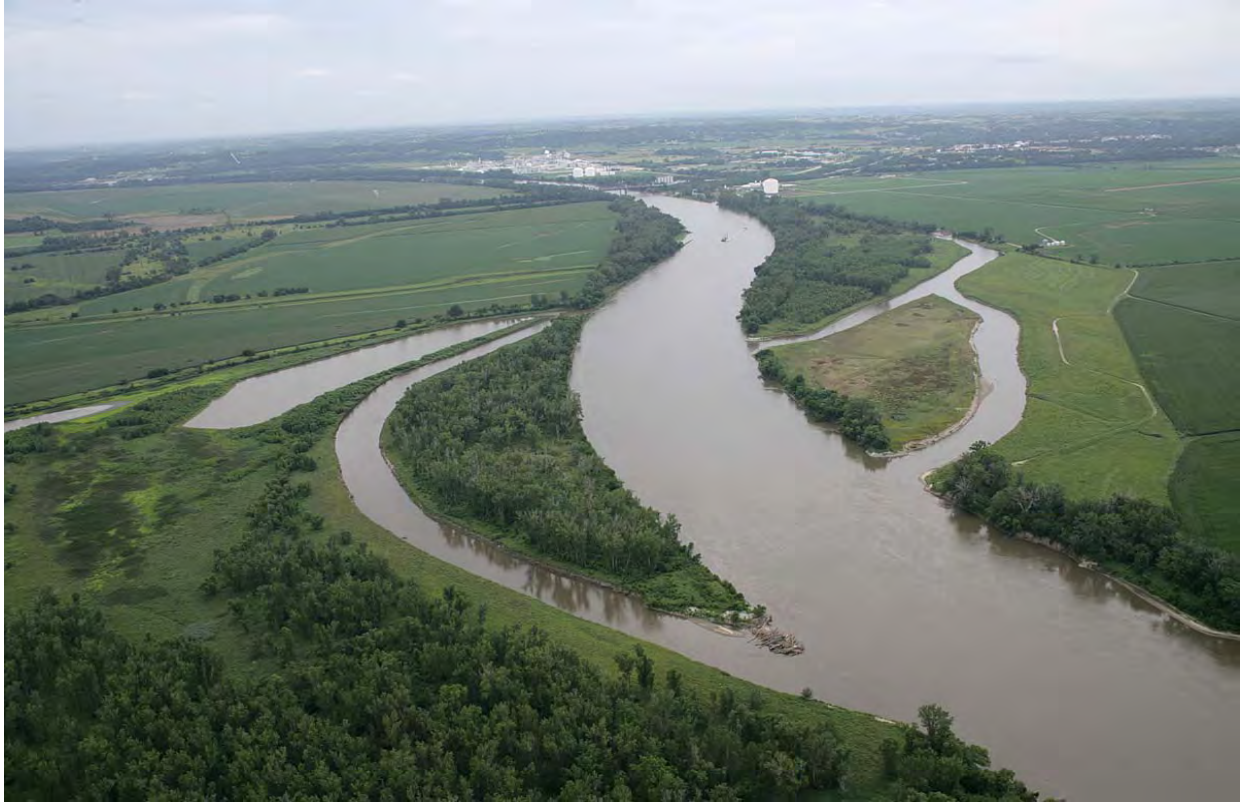
Figure 10 - Photo September 2008 California Chutes, looking downstream. Iowa on left (with backwater), Nebraska on right. Note deposition inside chute by woody debris.

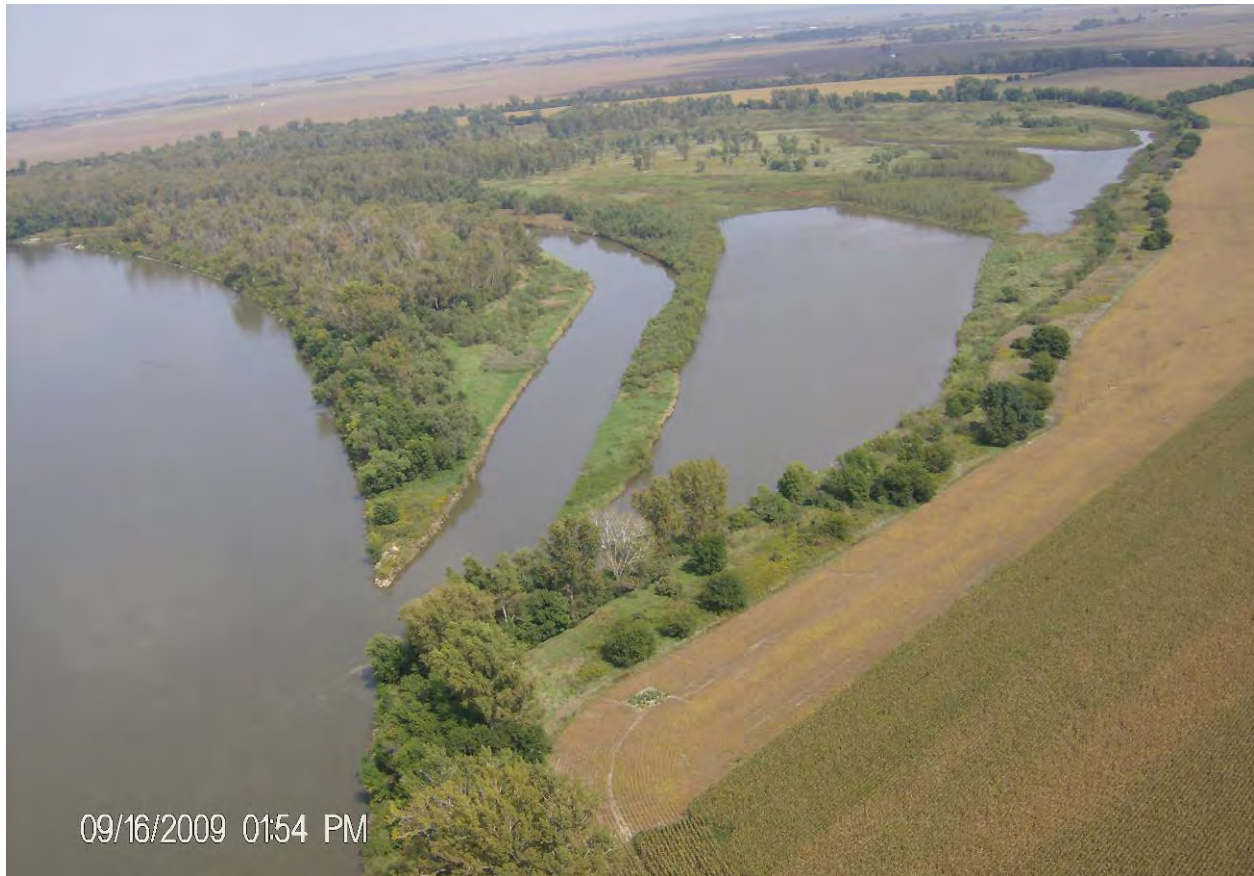
Chute measured velocities were between 2-3 fps. Active erosion was observed on both banks throughout the chute (figure 11 and 12). The downstream $\frac{1}{4}$ of the inlet is clogged with trees and debris, causing low velocities in the chute just downstream of this blockage. This has caused some deposition downstream of the inlet.

Figure 11 – Downstream of outlet looking upstream at chute and backwater. Note steep banks along chute.

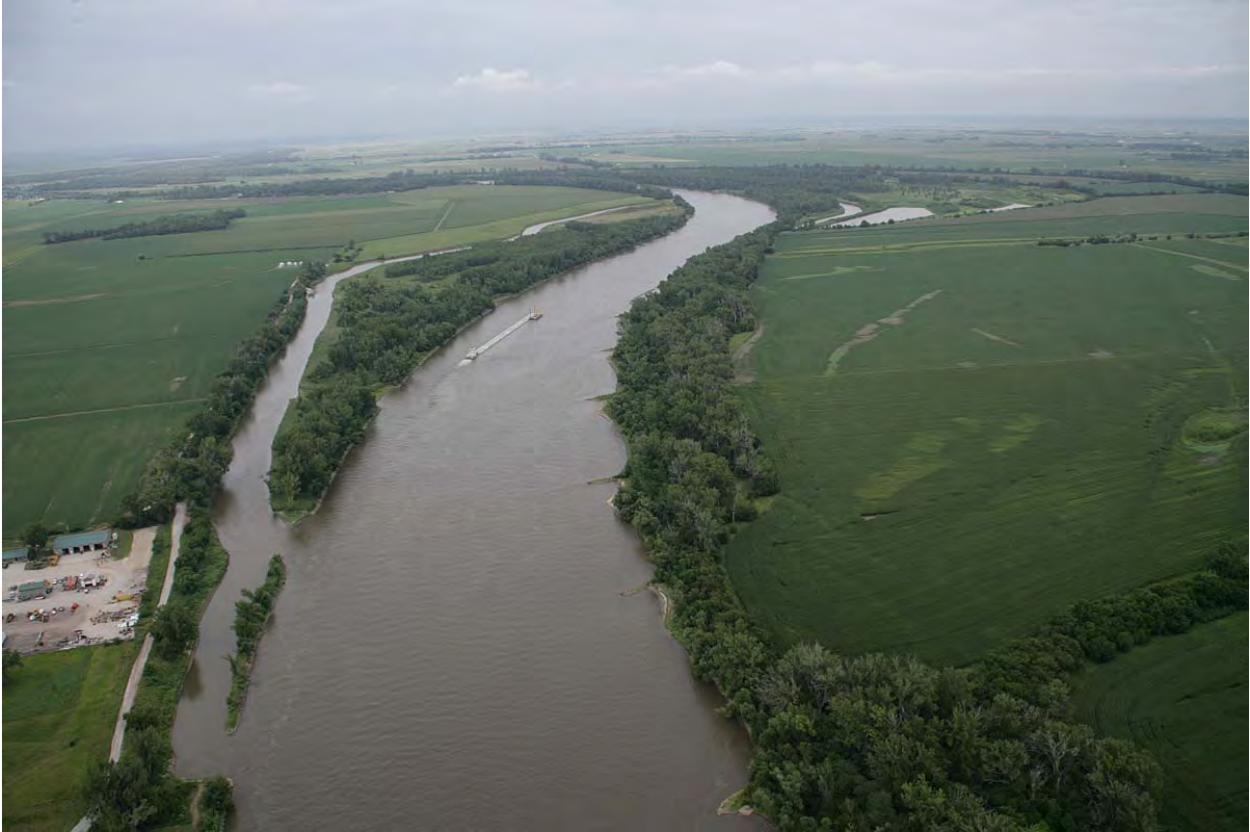
Figure 14 – Photo August 2008 downstream of California Chute NE (near) looking upstream at outlets.
Note the most upstream of the 3 outlets is hidden by trees.

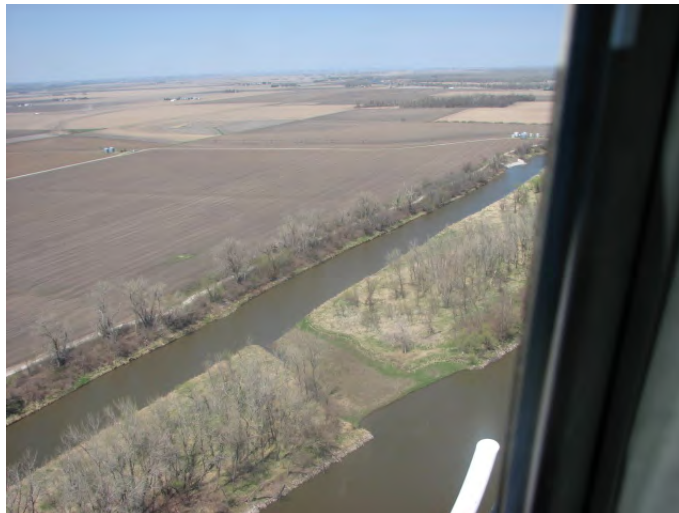
Figure 15 – Photo April 23, 2009 California Chute NE looking at the most upstream outlet, which only functions at a relatively high flow.

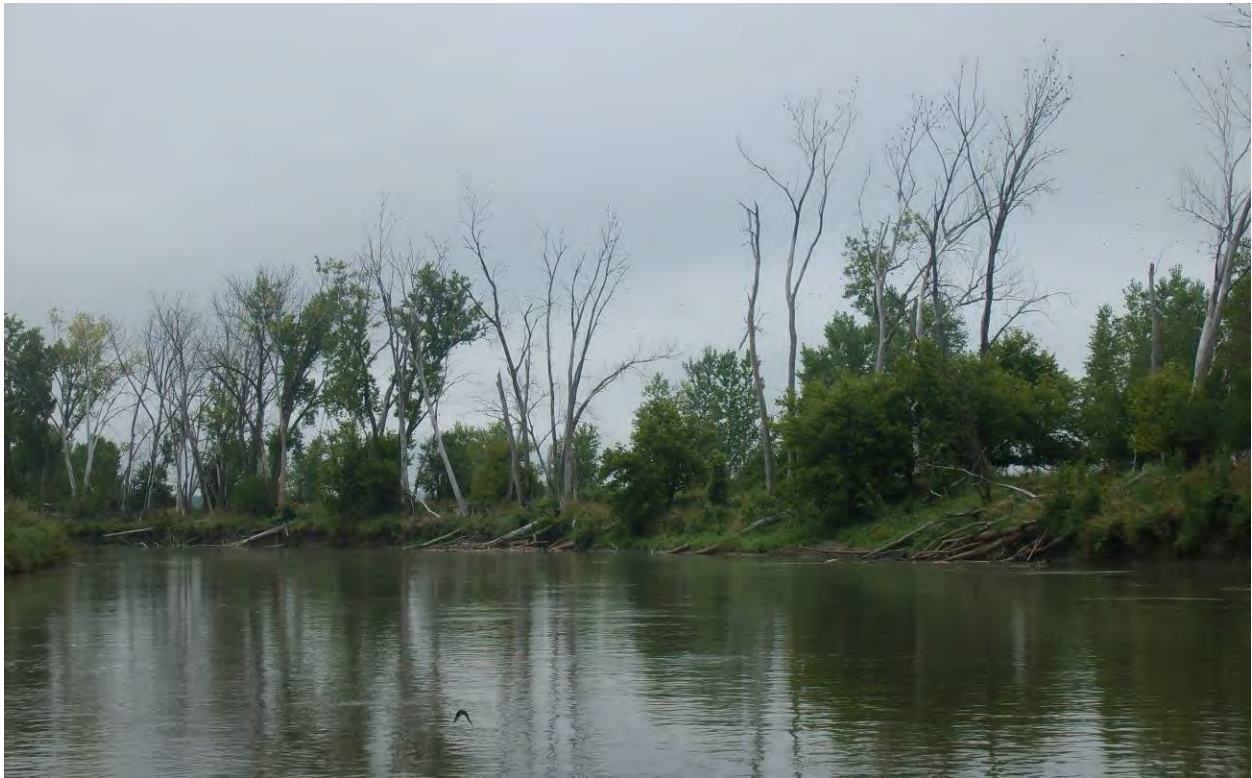
There is an abundance of dead, fallen and standing timber (Figure 18) in the chute and on the overbanks that is generally not observed in many of the other chutes. Figure 19 shows the lower section of the chute including the outlet.

Figure 18 – Photo August 28, 2009. Note logs on bank.

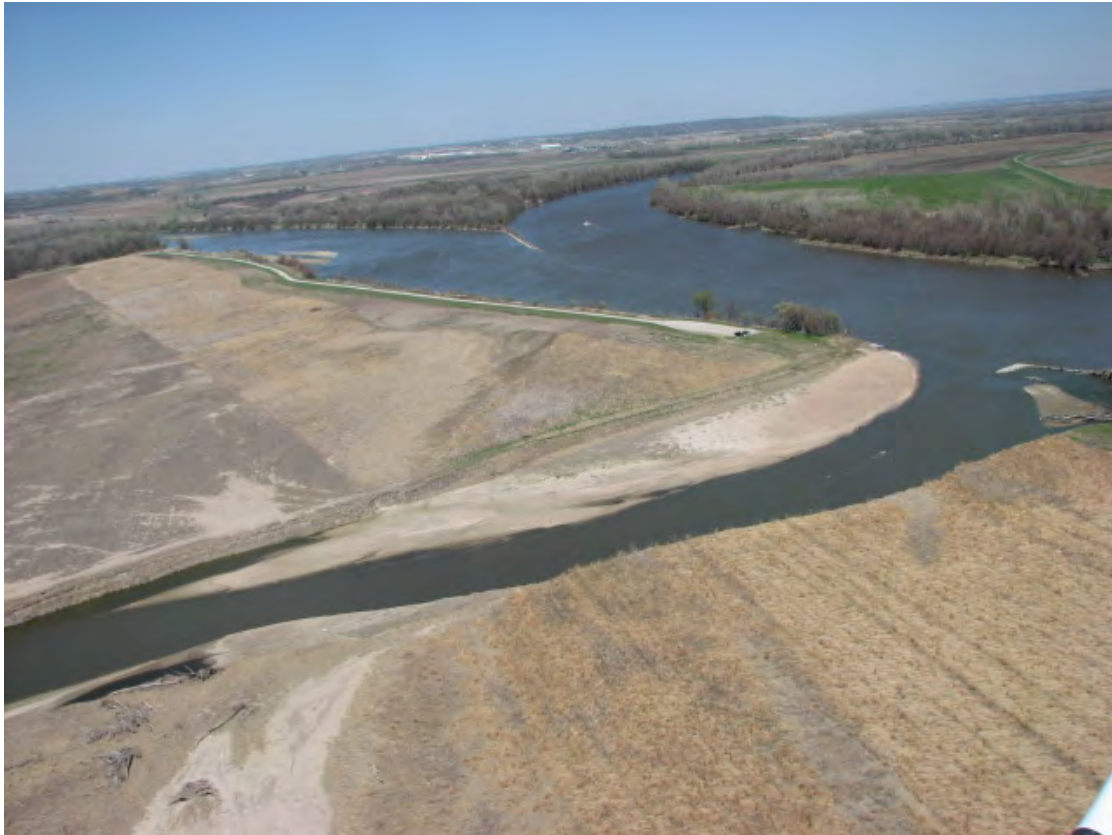
Deposition and erosion occurred throughout the chute. Signs of deposition in the chute include a sand bar developed along the right bank of the chute at and downstream of the inlet, Goose Lake and the chute are only connected during relatively high flows due to deposition in both the inlet and outlet, and many bars have developed in the chute itself. Banks on both sides are steep and erode due to the flow being direct to it or by changing water surfaces.

Figure 22 - April 23, 2009. Inlet to Plattsmouth chute with Platte and Missouri River confluence in the background. Note deposition in chute downstream of inlet.

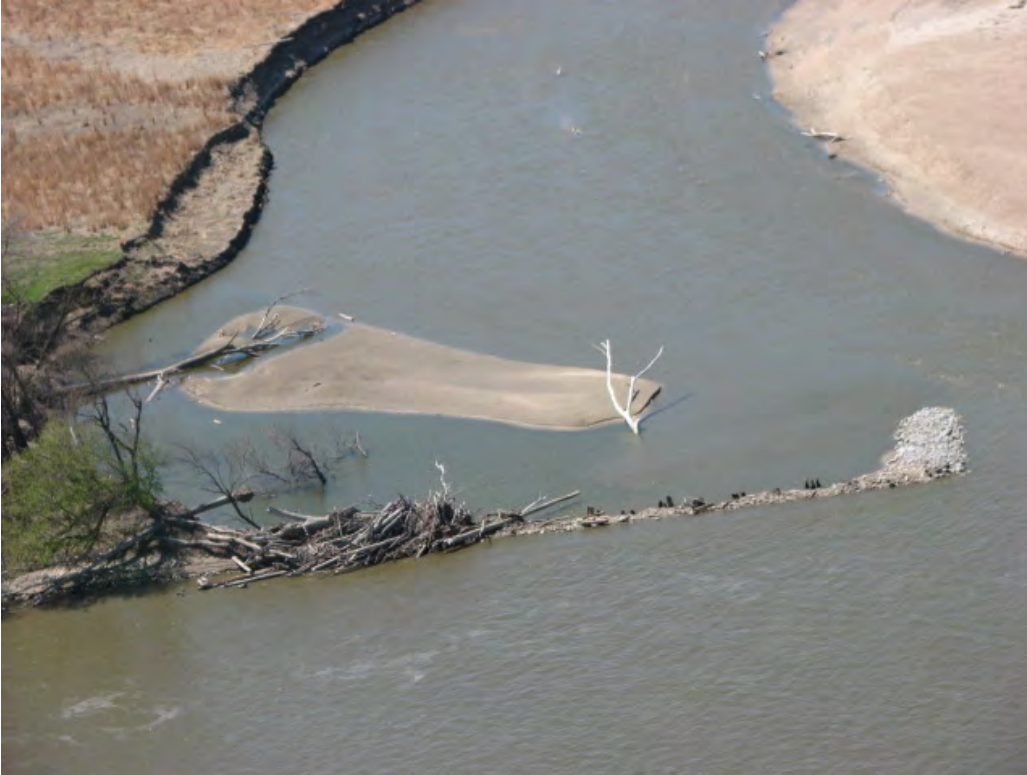
Figure 23 – Photo April 23, 2009. Inlet at Plattsmouth, note erosion of bank which is across from deposition in previous figure.

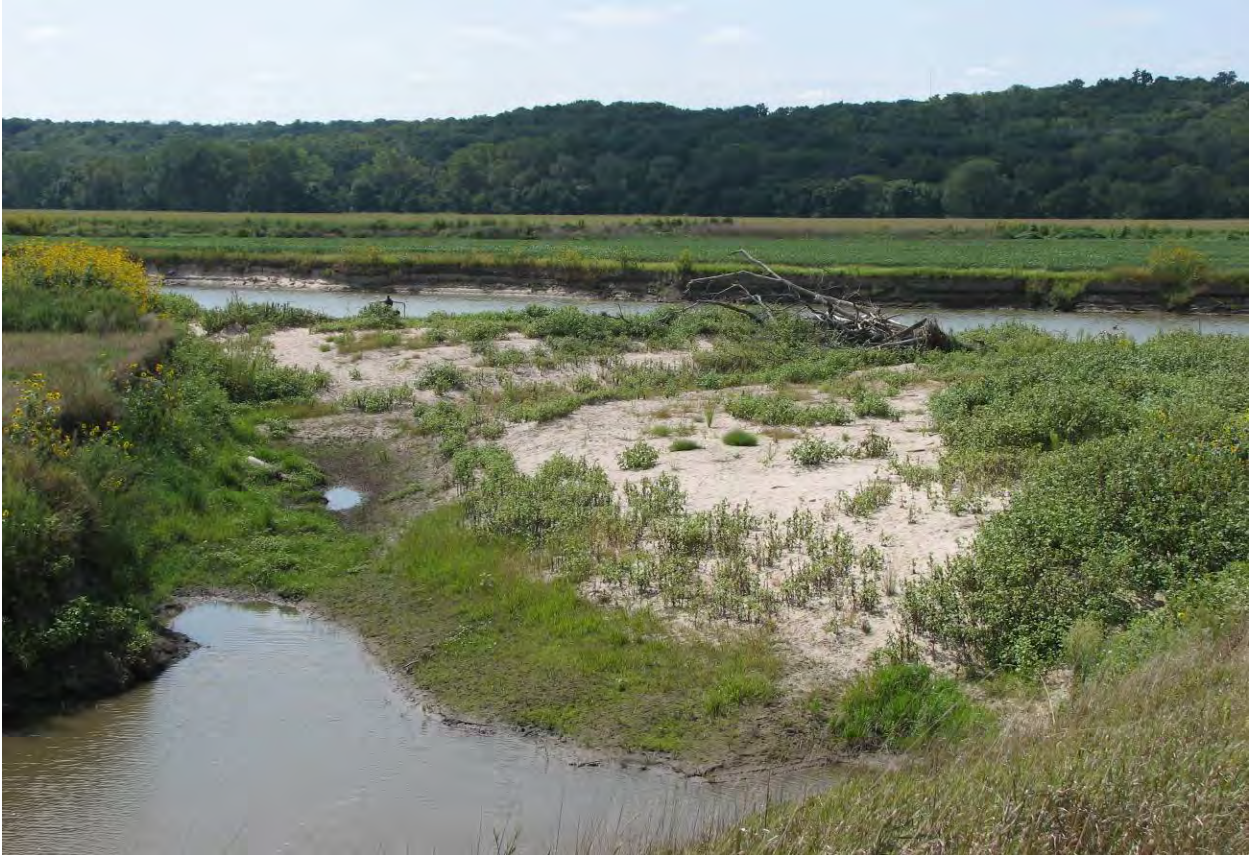
Figure 24 - September 1, 2009. Note deposition at inlet to Goose Lake.

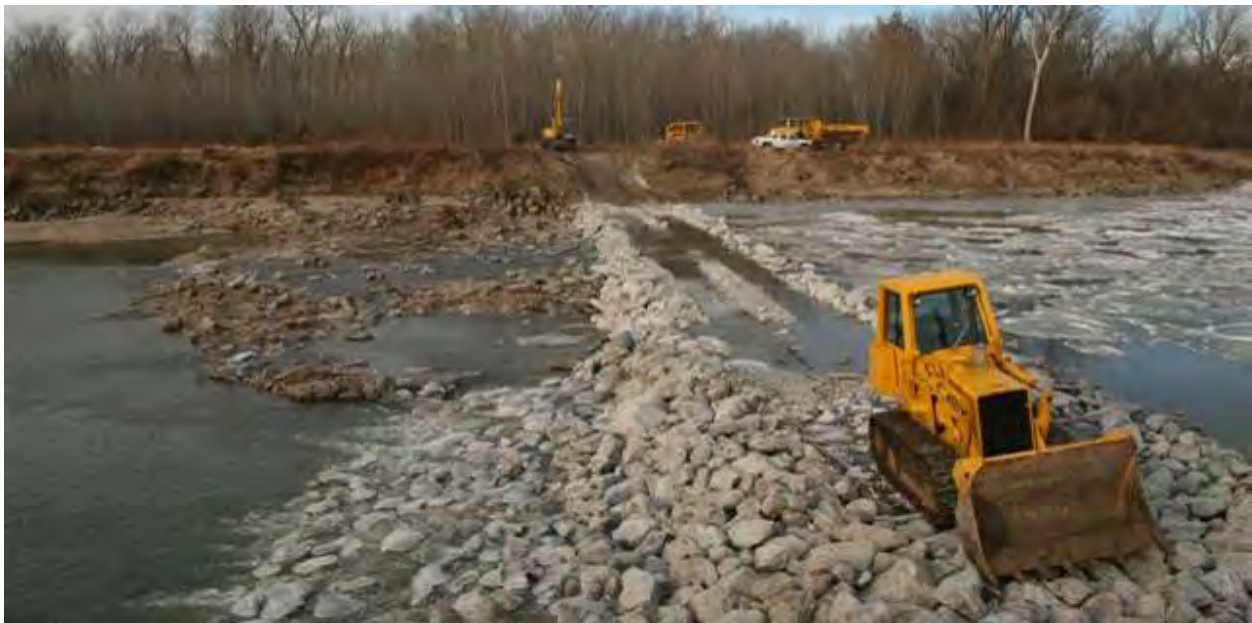
Upper Hamburg chute was surveyed on September 4, 2009 when the gage at Nebraska City was reading 42,600 cfs. At these flows, a hydraulic jump occurs at both the revetment notch and at the inlet grade control. Improvements to the grade control were made in December 2008. Figure 31 shows the chute under repair in 2008. Depths through the grade control notch show a bottom elevation of 900-901. The designed bottom of the notch is 902.2. The cause of this discrepancy has not yet been discovered, but might be due to higher than expected velocities through the notch washing material downstream. Downstream of both the revetment notch and the inlet grade control, there are large 30-40 foot deep scour holes. No plan has yet been developed to fix this problem, and flows through the chute are still exceeding the design standard of 8-10% of total river flow. Structures constructed in the river in combination with high flows have temporarily solved the shoaling problem within Hamburg bend.

Figure 31 - December 17, 2008. Construction repair to the upstream grade control.

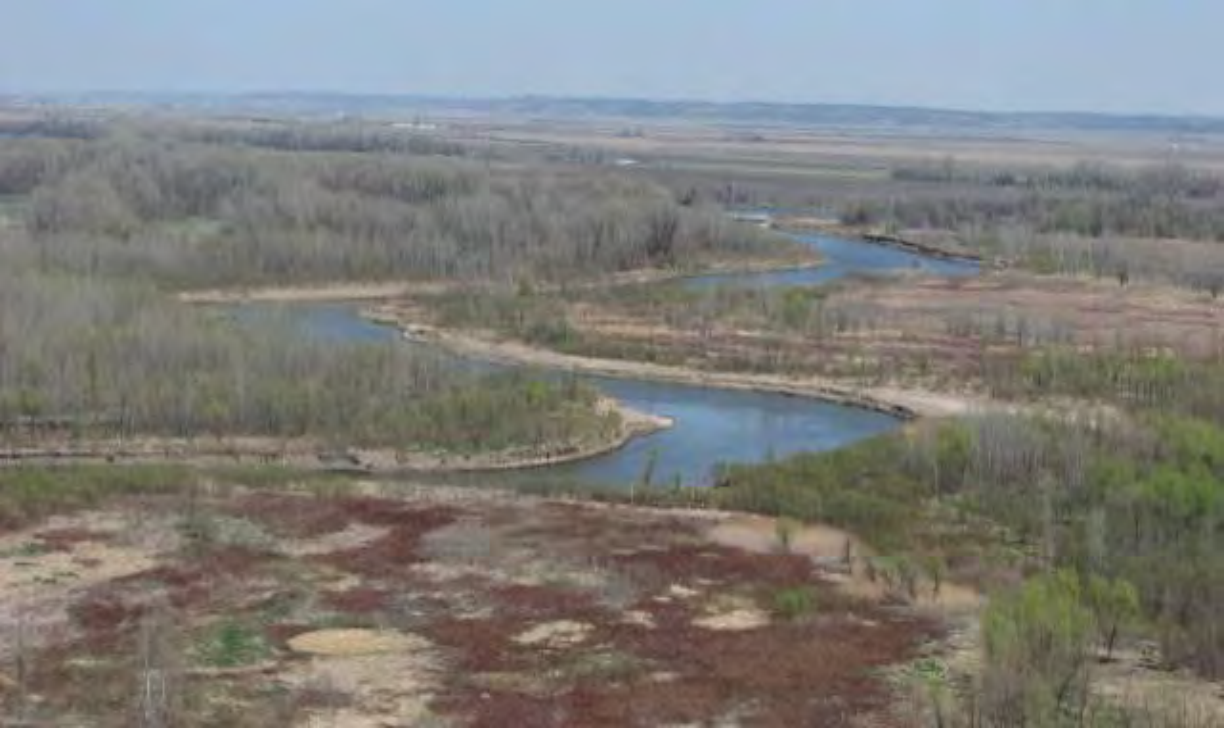
The chute looked very natural with both areas of erosion and deposition (Figures 32-34).

Figure 32 - April 23, 2009. Chutes interior, note overbank vegetation.

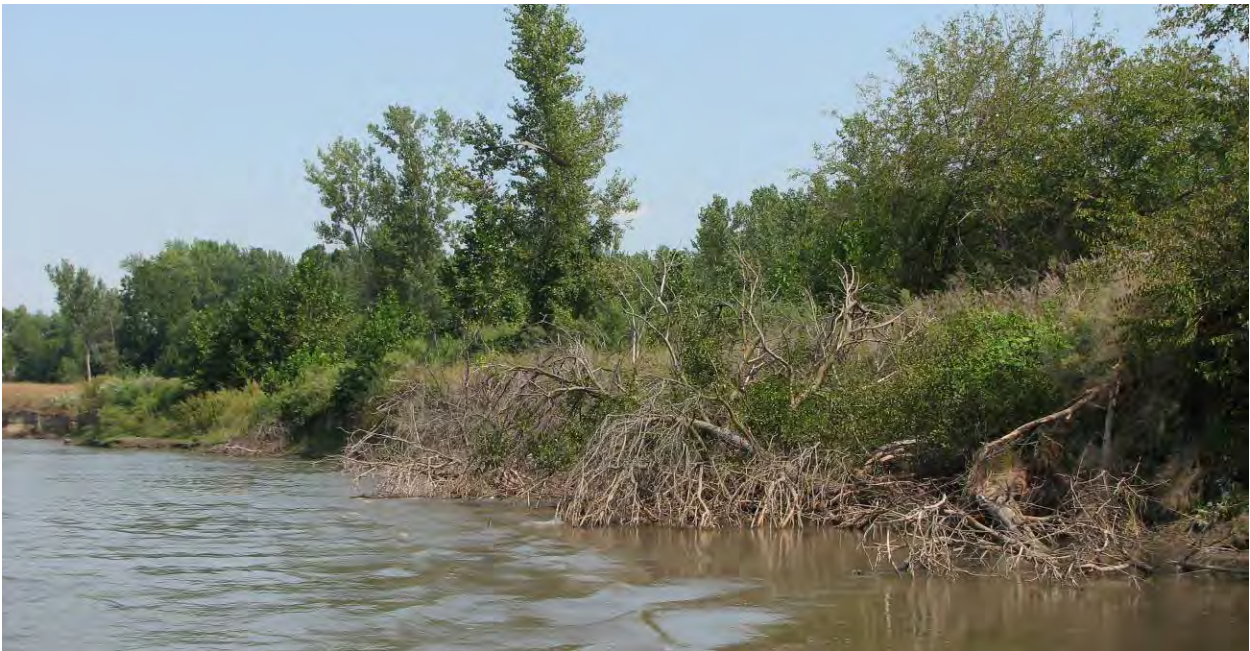
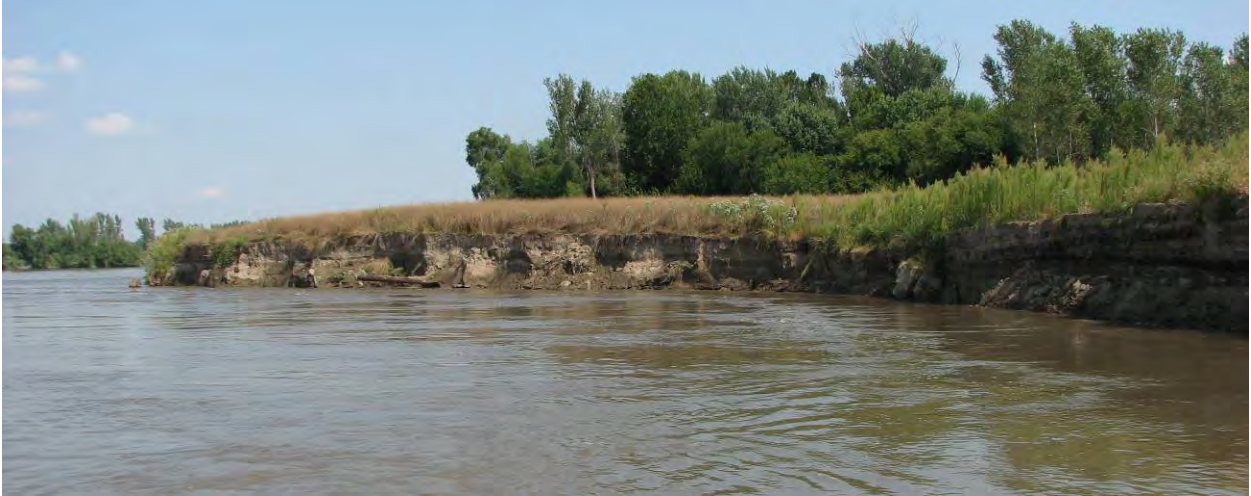
Figure 33 - September 15, 2009. Photo of the river bank in Hamburg Chute.

Figure 34 - September 15, 2009. Photo of the river bank in Hamburg Chute.

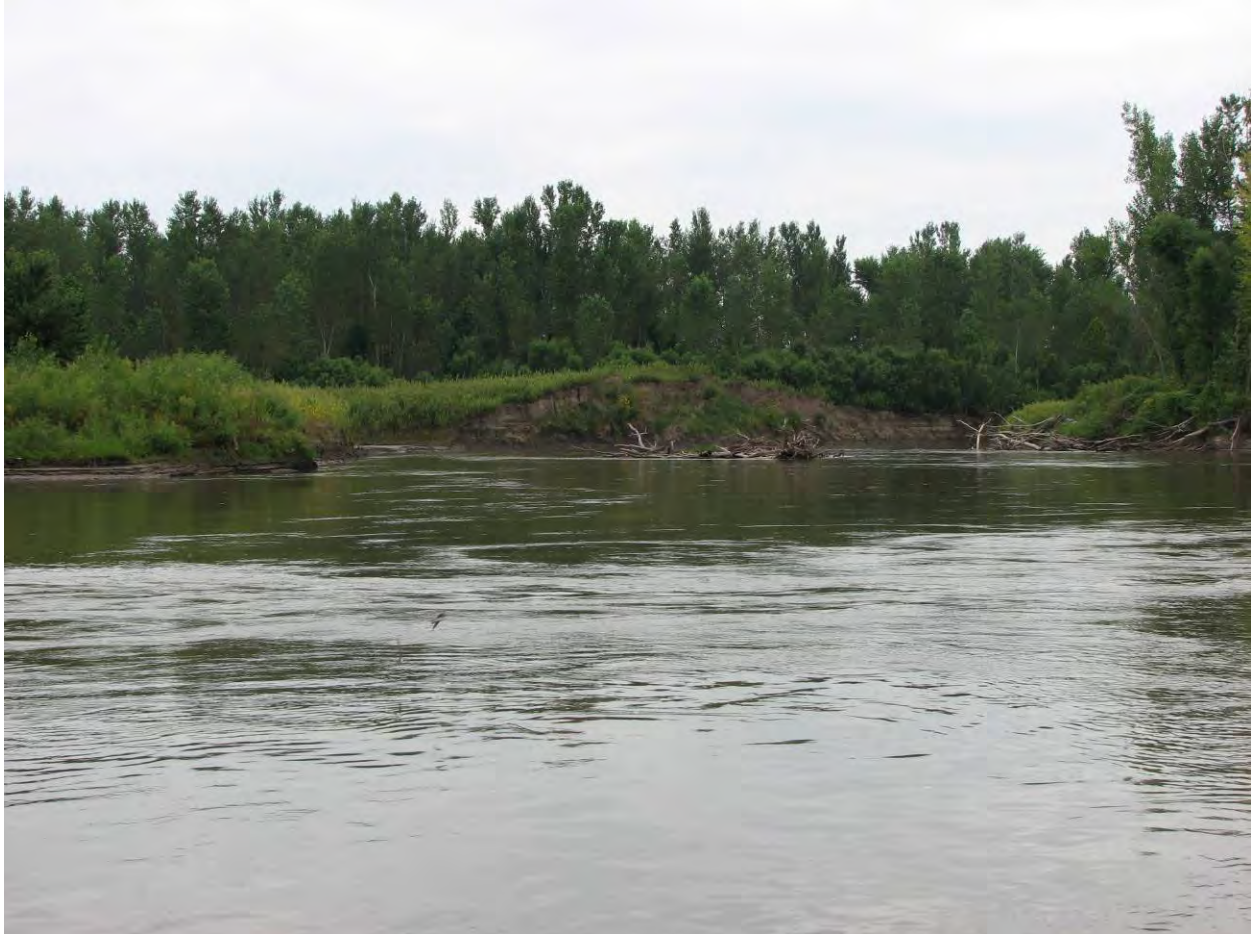
Rush Bottom Chute was surveyed on September 2, 2009 when the gage at Rulo, NE was at 39,500 cfs. There is active erosion occurring on the left bank just downstream of the inlet. See Figure 45.

Figure 45 – September 2009 inlet to Rush Bottom Chute. Note vertical bank and woody debris.
